CITY OF BALTIMORE SMOKE TESTING OBSERVATION SUMMARY JONES FALLS SEWERSHED

BALTIMORE CITY PROJECT 994 REI/DRAYCO

Unique Test ID: 378 Date: 07/16/2008 Basin: JF-19

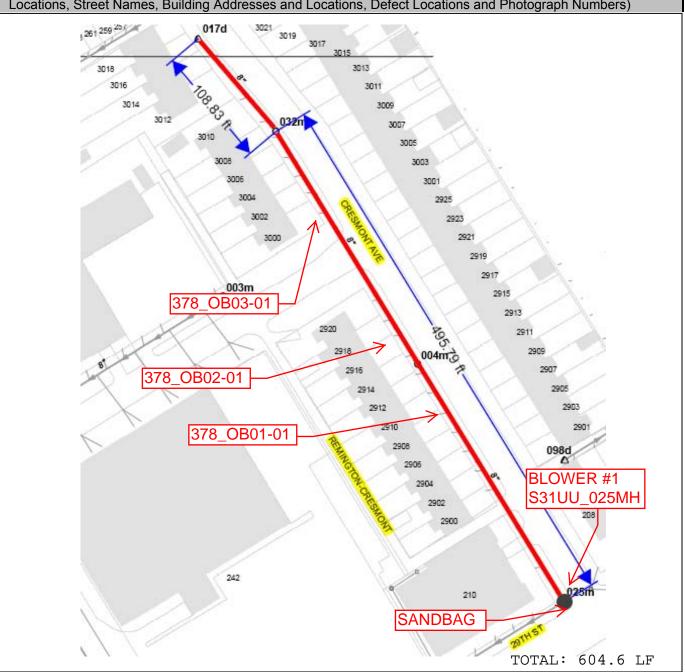
Field Sketch: (Show All Manholes with Numbers, Blower Placement Location, Sandbag or Isolation Locations, Street Names, Building Addresses and Locations, Defect Locations and Photograph Numbers)

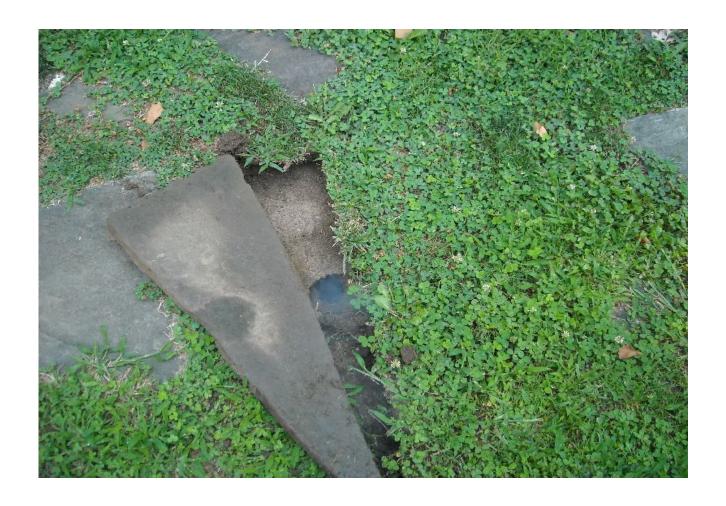
Photograph No: OB01-01 Filename: 0994-378_OB01-01.jpg

Address: 2908 CRESTMONT AVE.

Source Type: 03 Location: 07 Severity: 03

Comments: CLEAN OUT - BELOW GRADE UNDER STONE - NO CAP - FRONT OF HOUSE

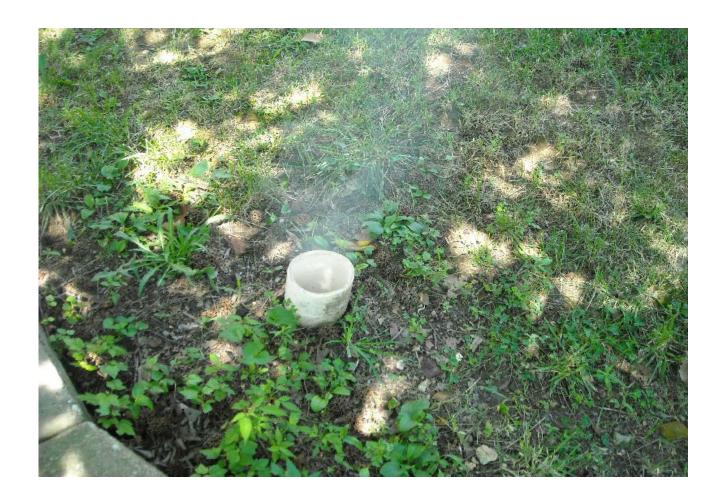
Photograph No: OB02-01 Filename: 0994-378_OB02-01.jpg

Address: 2916 CRESTMONT AVE.

Source Type: 03 Location: 07 Severity: 03

Comments: CLEAN OUT - ABOVE GRADE - NO CAP - FRONT OF HOUSE

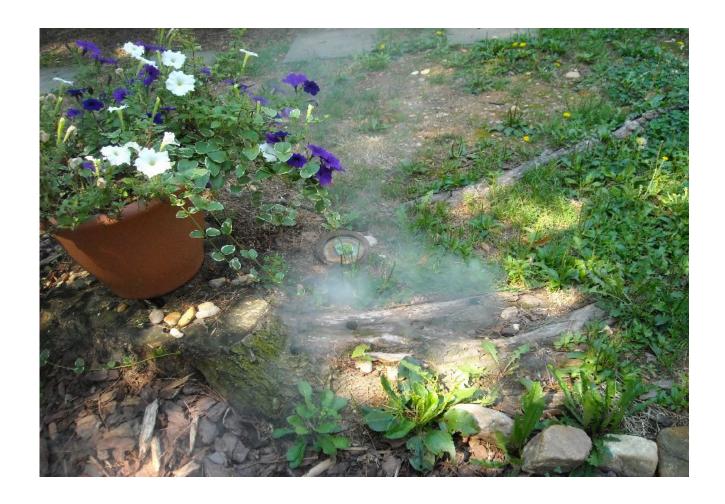
Photograph No: OB03-01 Filename: 0994-378_OB03-01.jpg

Address: 3000 CRESTMONT AVE.

Source Type: 03 Location: 07 Severity: 03

Comments: CLEAN OUT - AT GRADE - NO CAP - FRONT OF HOUSE
